**RE: Duke Energy Carolinas, LLC and Duke Energy Progress, LLC's
Response to September 8, 2016 Order Requiring Response and
Requesting Comments
Docket No. E-100, Sub 101**

Duke Energy Carolinas, LLC and Duke Energy Progress, LLC
Joint Responses to Questions Presented in September 8, 2016 Order
Docket No. E-100, Sub 101

PUBLIC STAFF DATA REQUEST
July 8, 2016

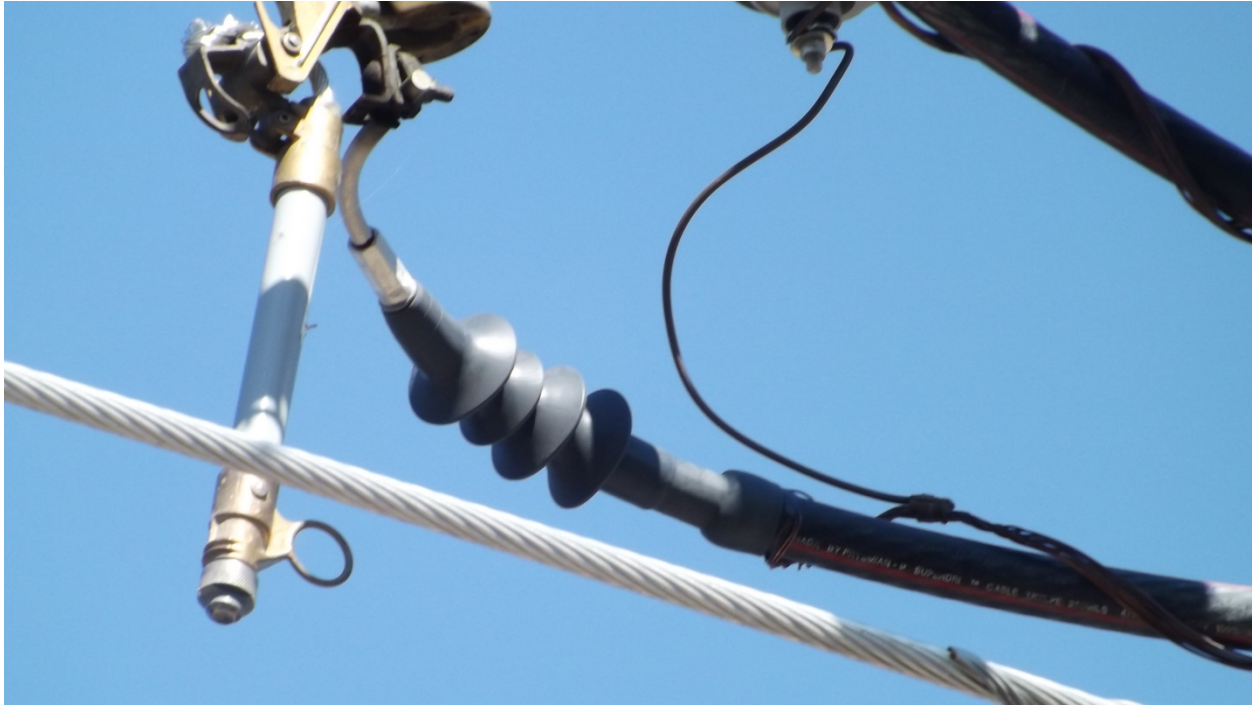
Later that day on February 26, Duke Energy contacted Strata to inform them that Duke would be disconnecting the facility that day, and would reconvene with Strata on Monday February 29 to discuss next steps. On February 29, several Duke Energy personnel visited the Holstein Site, in conjunction with Strata personnel, and both parties conducted a visual inspection of Strata's medium voltage overhead facilities. Duke engineering staff on site determined that there were inadequate clearances between the many of the cable terminations and nearby ground wires (there to connect underground cable concentric neutrals to lightning arresters mounted above the cutouts). Duke

Exhibit 1-5: inadequate clearance between ground wires and cable termination

Strata agreed to retrain/reroute the ground wires that day, since they had a distribution maintenance crew on site. Strata further agreed to replace the “C” phase cutout and to re-orient the cable terminations to be brought up vertically underneath the cutouts.

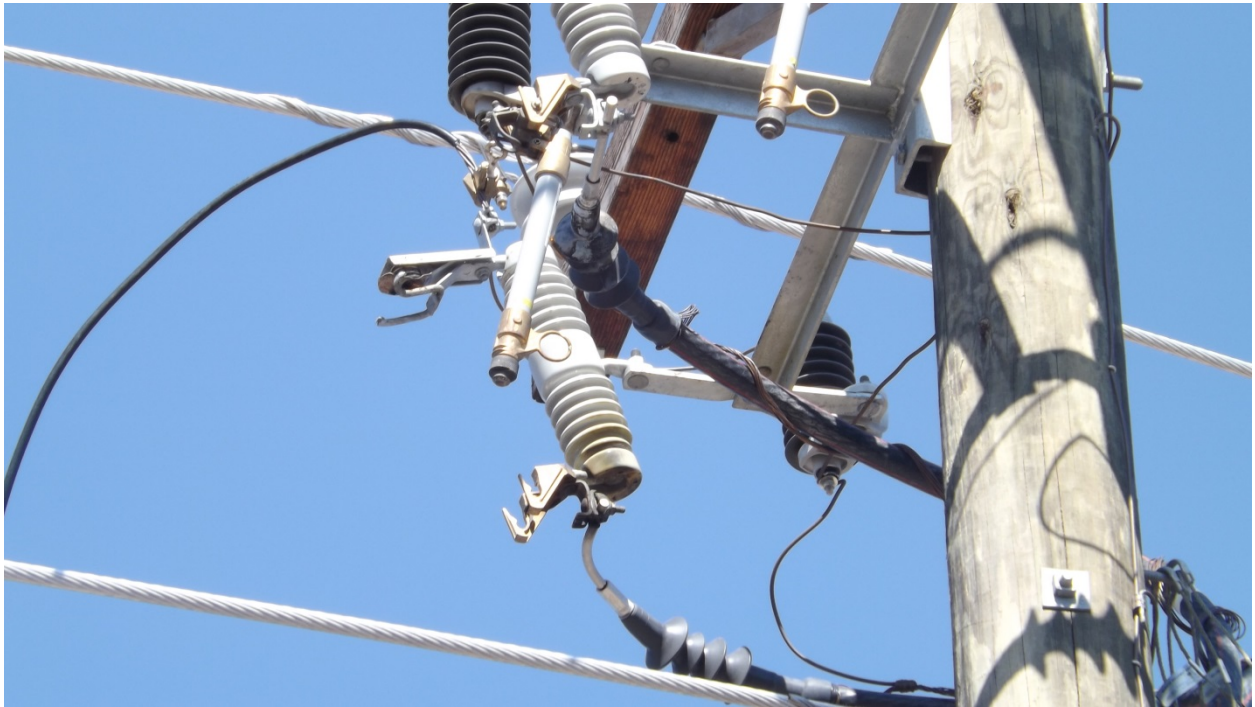
and Strata personnel also both noted the brown flash marks at the bottom of the “C” phase cutout on the middle dip pole, and also flash marks on the “B” phase cable terminations. Duke further noted that the cable terminations were installed horizontally at the bottom of the cutouts, typically not a permitted installation method by termination manufacturers. See Exhibit 1-5 for a photo of the clearance issues, Exhibit 1-6 for a photo of the damaged cutout, and Exhibit 1-7 for a photo of the horizontally-oriented cable terminations.

Exhibit 1-6: damaged cutout

A series of actions took place in the days ahead in which Strata made repairs and prepared to restart the facility. After replacing the “C” phase cutout and re-energizing, a Duke technician performed a thermographic IR (infrared) scan of the middle dip pole, and discovered heating on the replaced cutout, implying a damaged cutout or a loose connection. See Exhibit 1-8 for a photo of the IR scan. Duke informed Strata, and they replaced the cutout a second time. By mid-March the facility was back on-line.

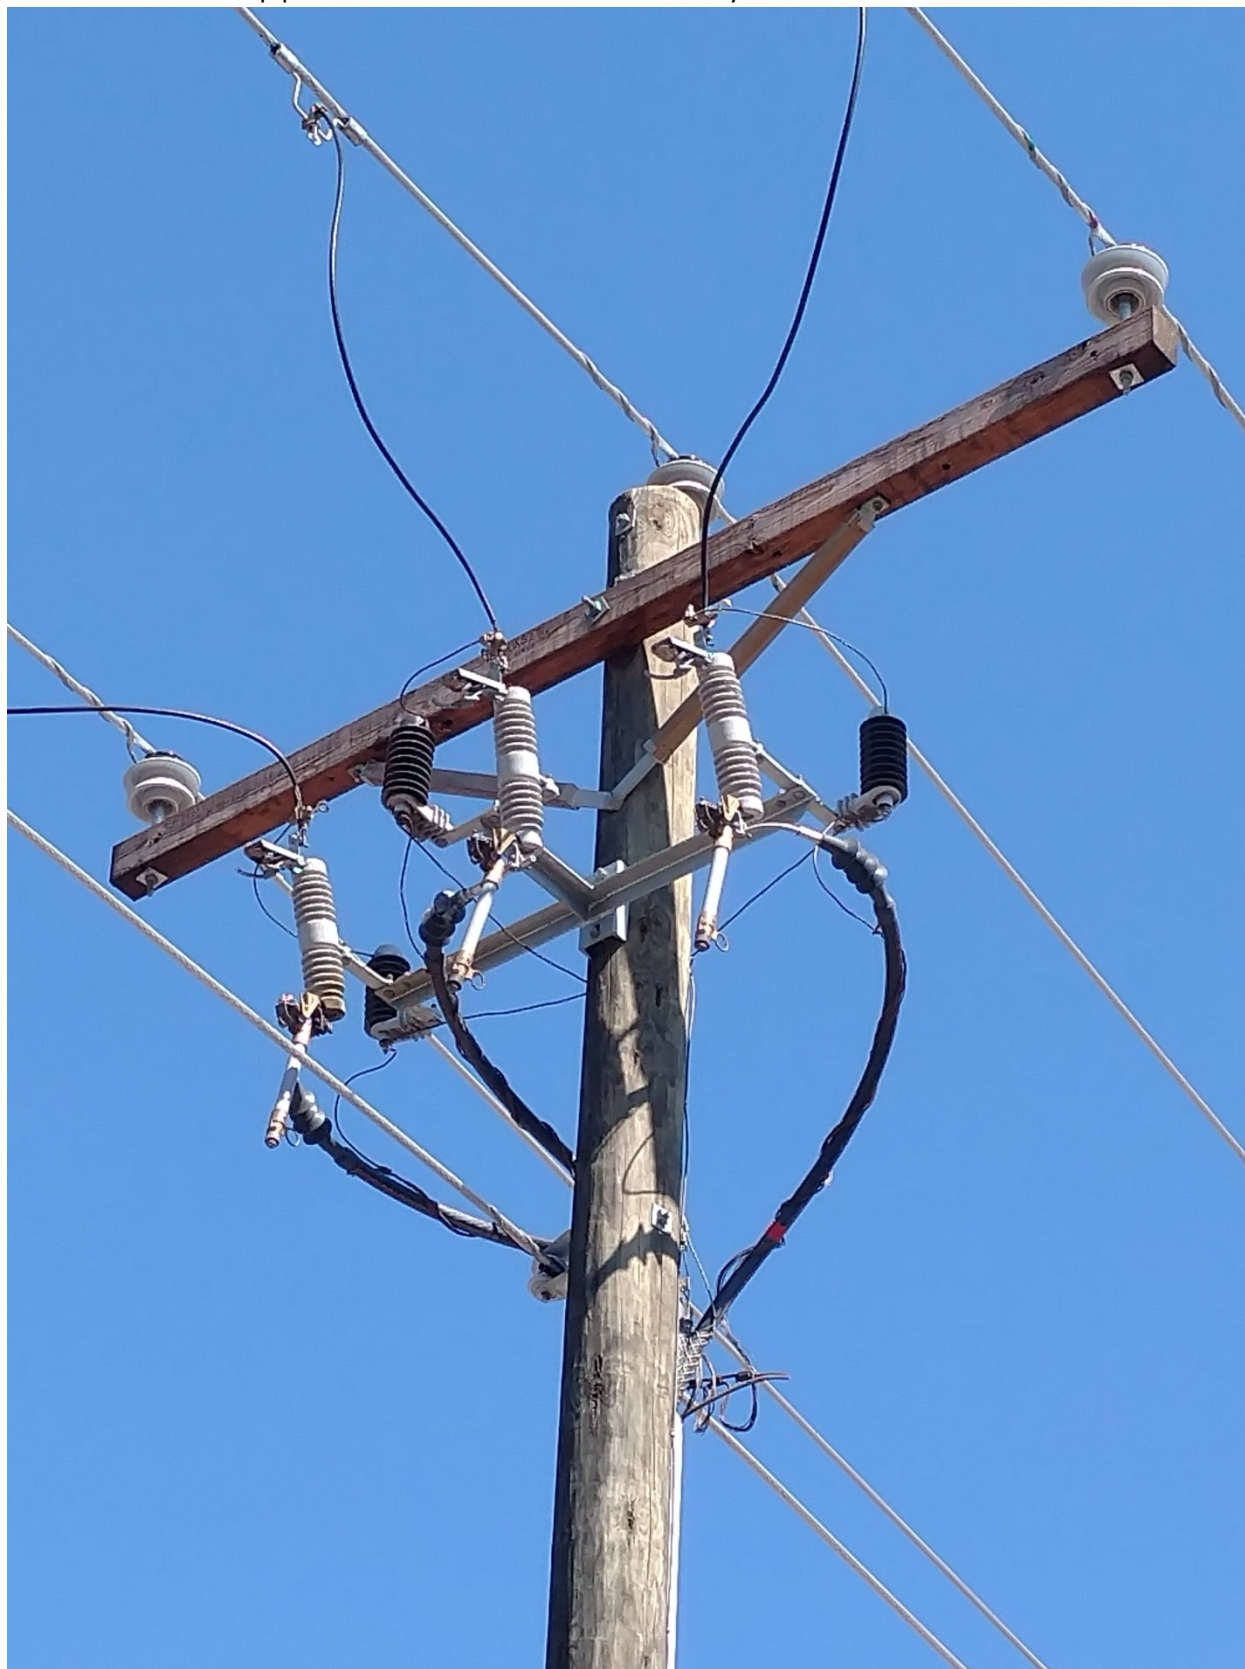
Exhibit 1-7: middle dip pole overview and view of horizontally-mounted cable terminations

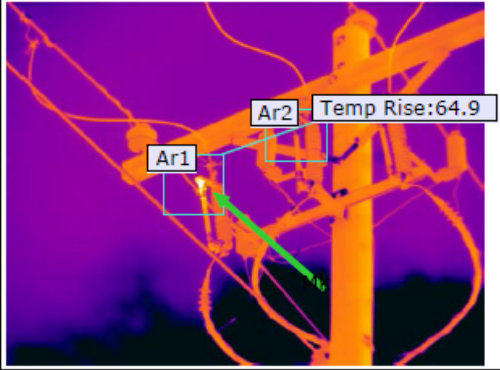
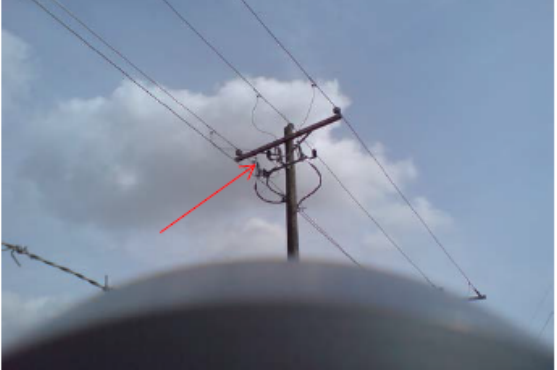
Exhibit 1-8:

Date: 3/10/2016 Time: 1:00:26 PM File Name: IR_2254.jpg	The field phase cutout barrel is starting to heat on jaw side or the Cap side of the barrel.

Temperature Rise	64.9 °F	Condition	Serious
Point of Concern Temperature (Ar1)	145.2 °F	Upgrade	
Reference Temperature (Ar2)	80.3 °F

This was a second follow up IR Scan on 3/10/2016 after this pole had been repaired from recent problems. This barrel should be inspected and repaired to stop the heating condition. This may be the fuse and cap not installed correctly or dirty contacts in jaw or barrel or the contacts in the jaw of the cutout not making good contact. Just wanted to make you aware of this condition. It was not heating on the scan the day it was put back in service but was today.

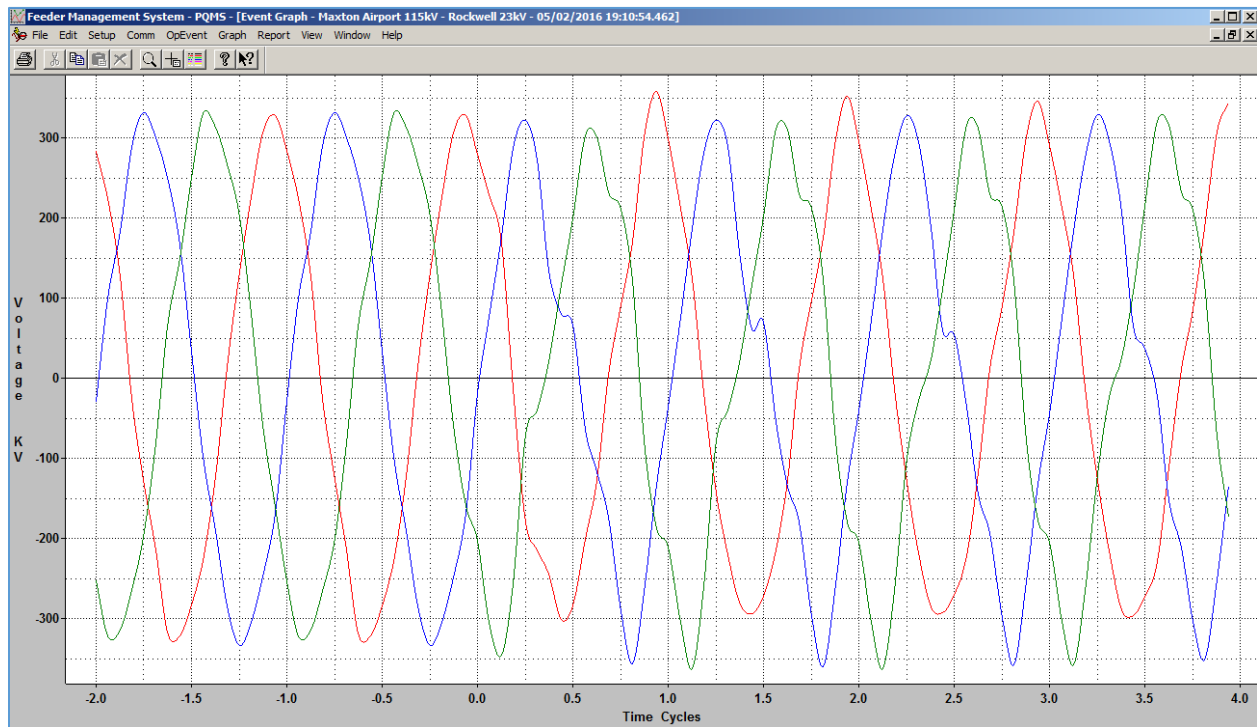
Exhibit 2-1a: Note breaker close at $t=0$; note typical harmonic distortion during first 4 cycles of inrush

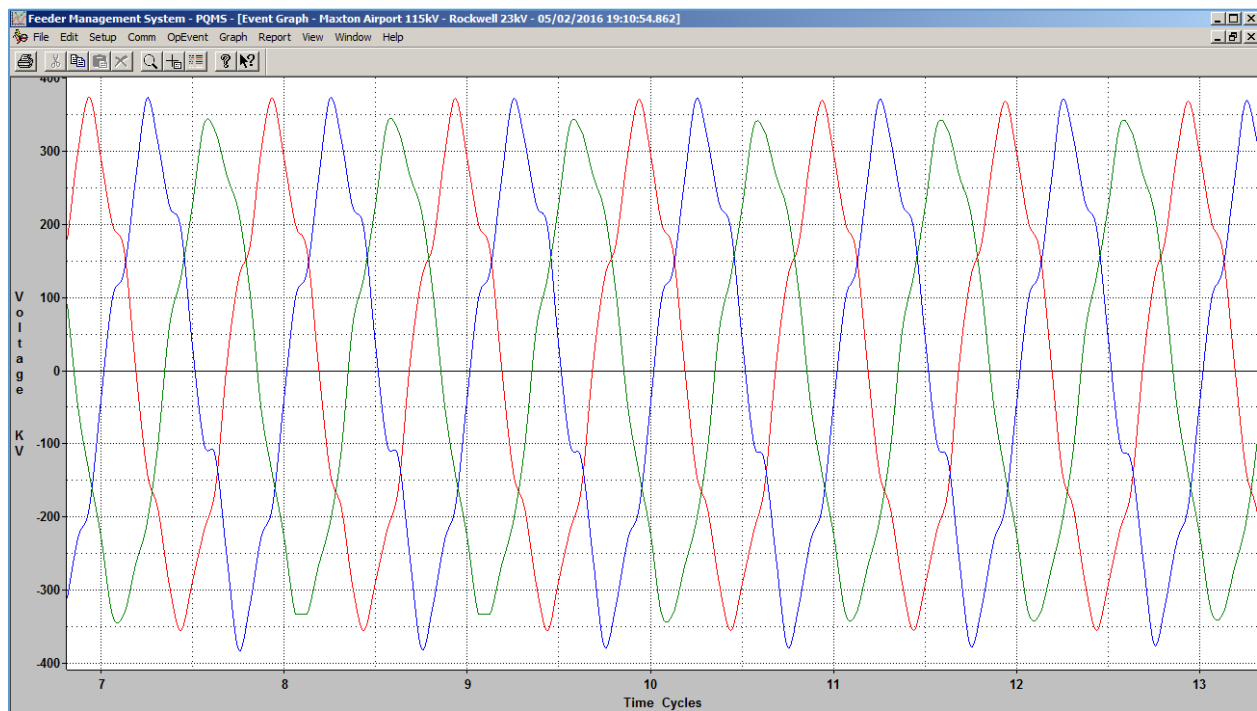
Exhibit 2-1b: Note phase voltages at 31 -- 37 cycles after breaker closing, with diminished harmonic distortion

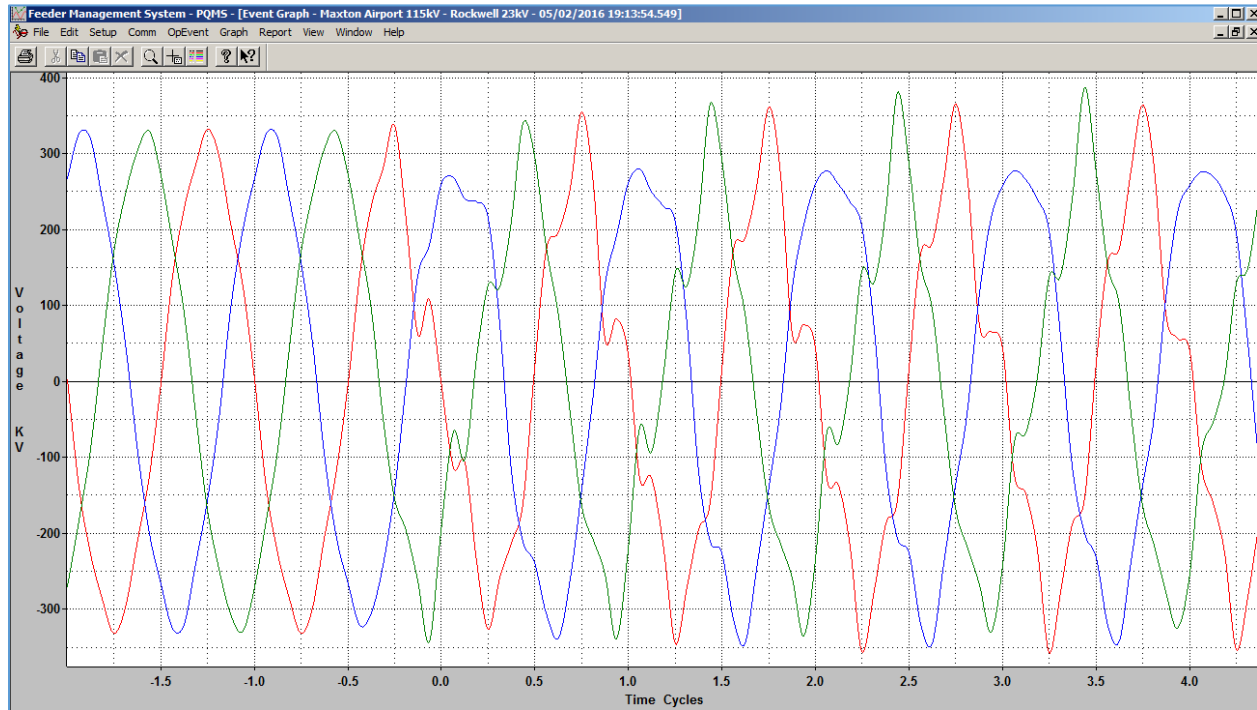
Exhibit 2-2a: Note recloser closes at $t=0$; note first 4 cycles of inrush with significant harmonic distortion

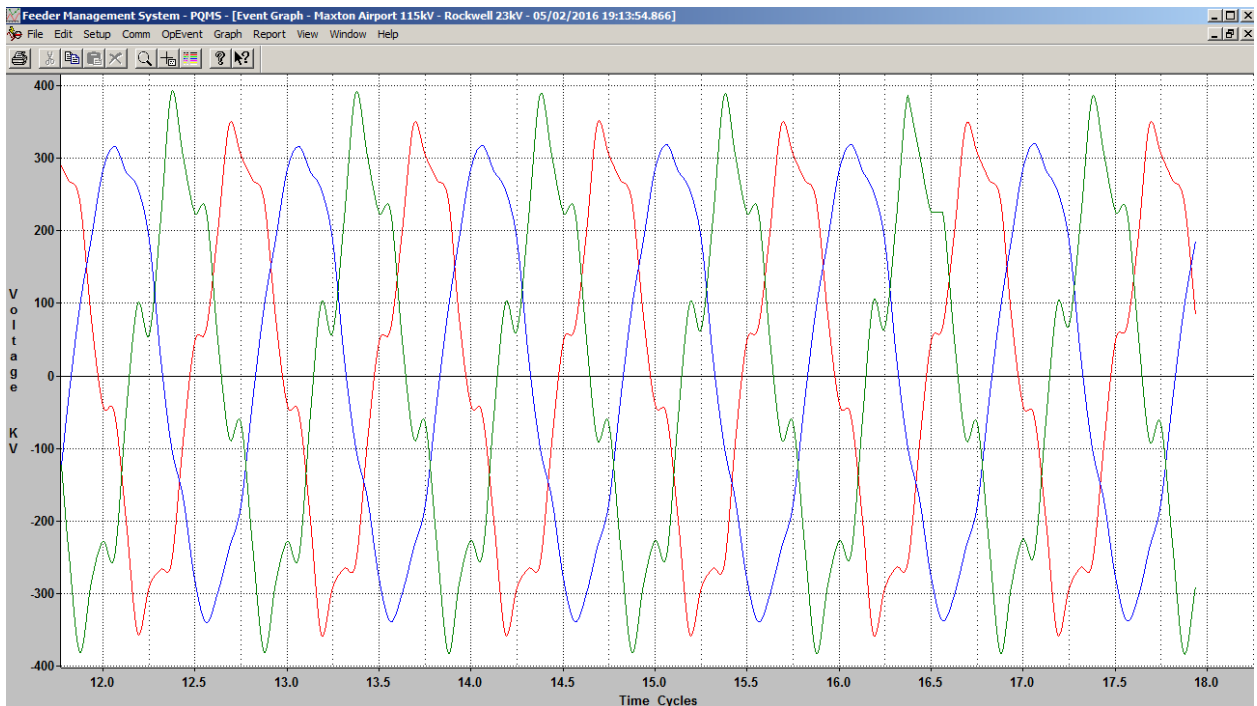
Exhibit 2-2b: Note phase voltages at 31 -- 37 cycles after breaker closing, with sustained and significant harmonic distortion

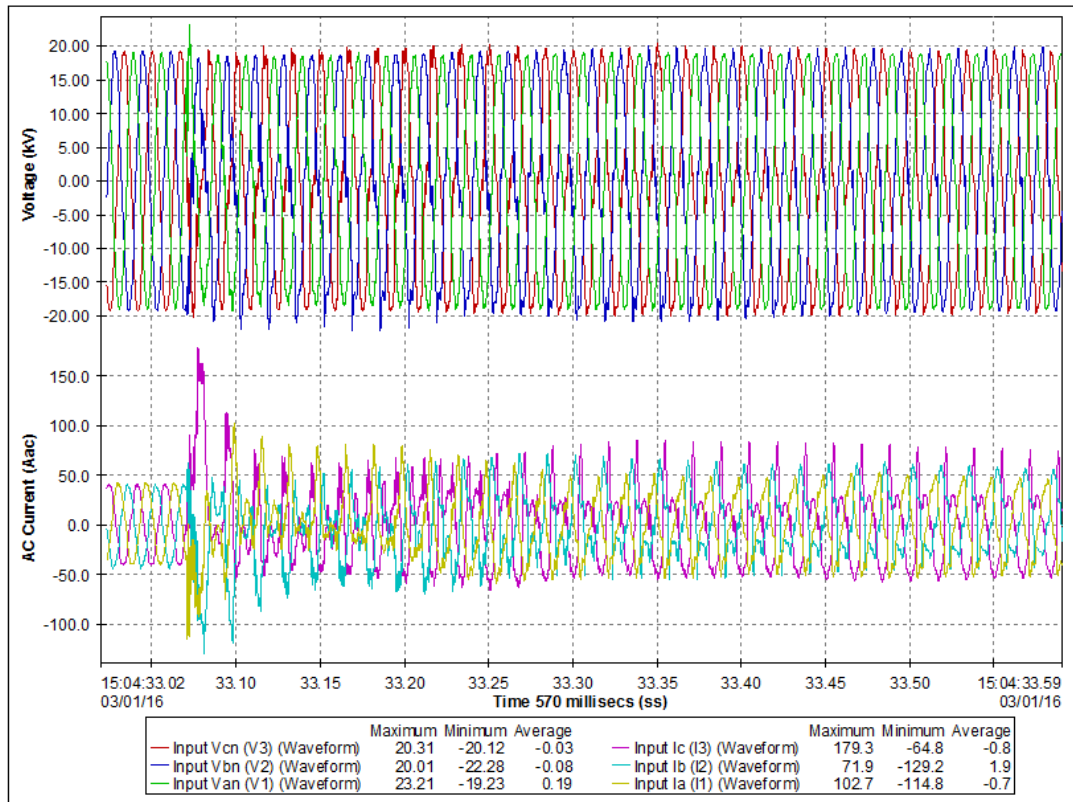
Fresh Air Energy XII DIS # 18AN98

Exhibit 3-3a: Harmonic voltage and current response at the Fresh Air XII site POI, to magnetizing inrush at the Wilson 1 site. Note the excessive harmonic distortion in voltages and currents at the Fresh Air XII POI.

Inverter response at Fresh Air site to transformer inrush from Wilson site

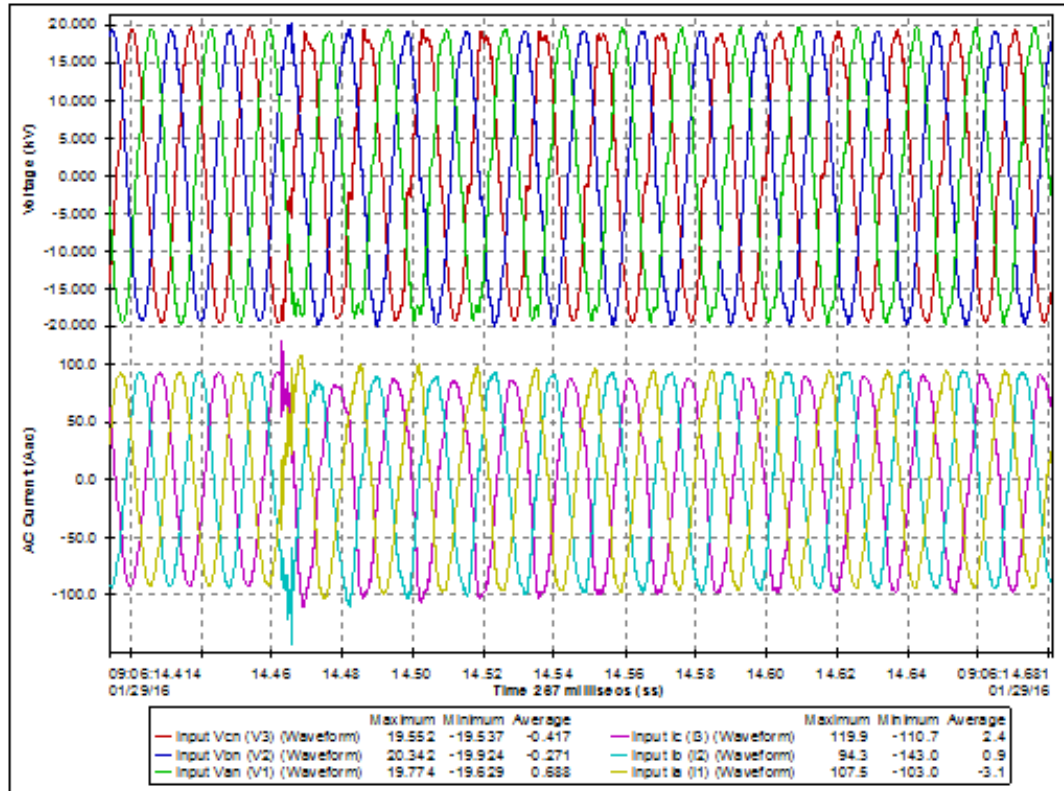
Wilson Solar Farm I DIS # 17QT84

Exhibit 3-3b: Harmonic voltage and current response at the Wilson 1 site POI, to inrush from the Fresh Air XII site connecting to the system. Note that there was little harmonic distortion associated with the inrush contribution seen at the Wilson 1 POI.

Inverter response at this site to transformer inrush from other solar farm.

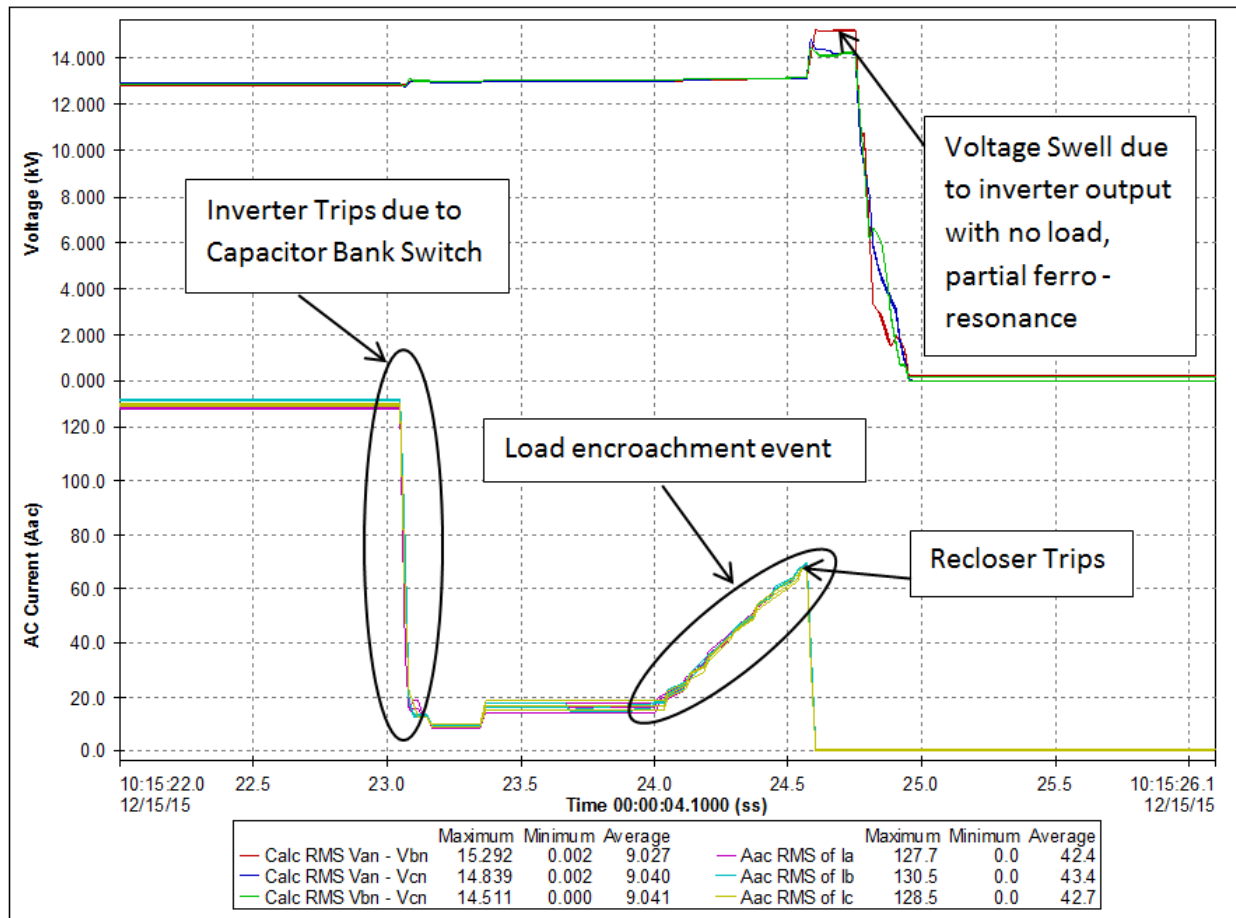
Exhibit 4-1: The following graph depicts the entire event in detail. Duration of graph is 4.1 seconds

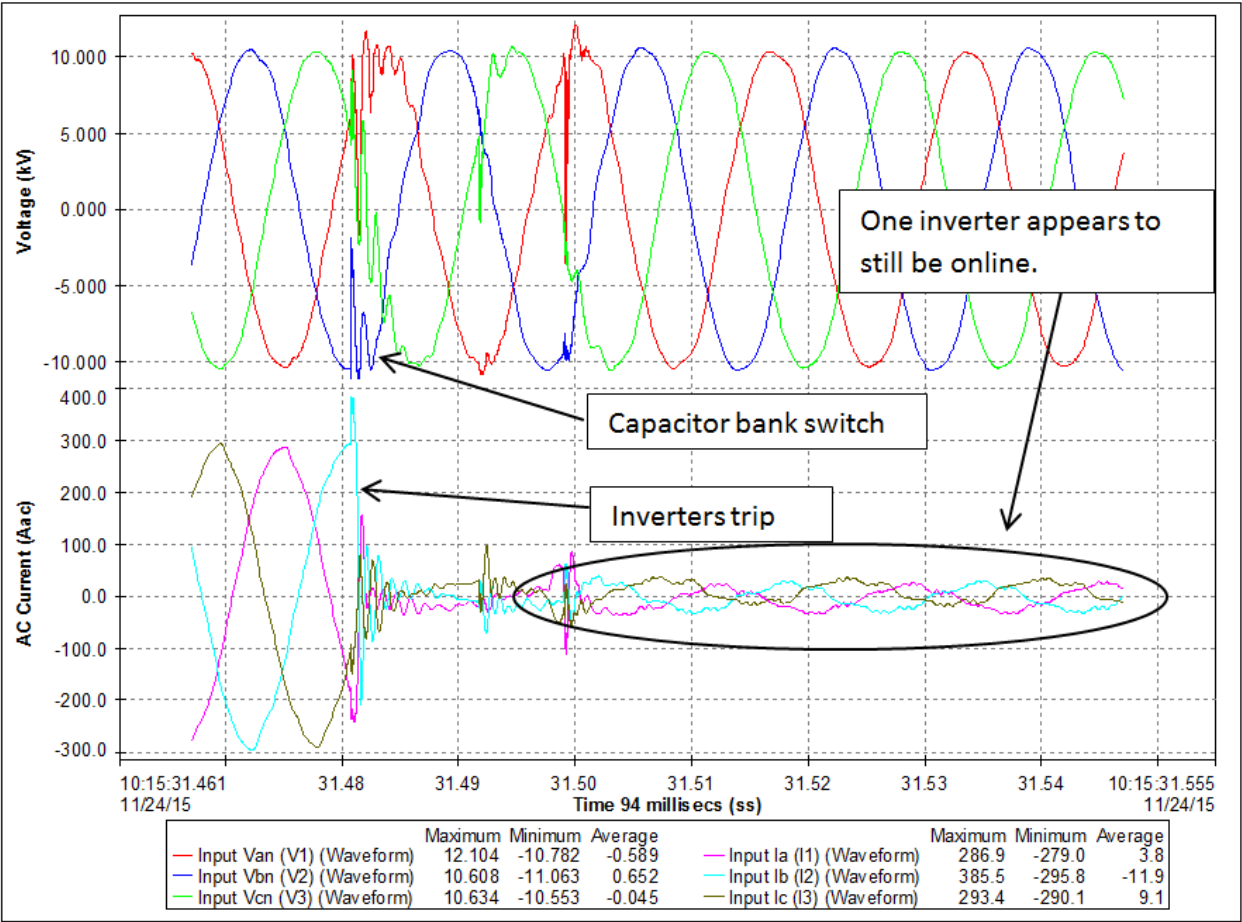
Exhibit 4-2: Waveform of the oscillatory ring wave from the capacitor bank switch. The current from the inverters on the current waveform below. Duration of graph is 94 milliseconds.
